**ROME STATE** (REO)(KREO) 20 SW UTC-8(-7DT) N42°34.66' W117°53.13'

**RWY 03-21:** 6000X150 (GRVL)

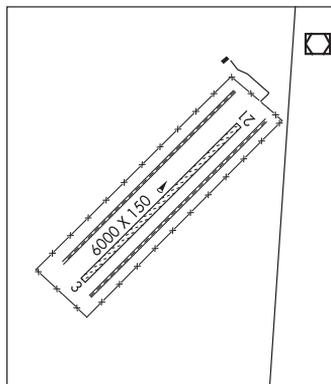
**AIRPORT REMARKS:** Unattended. Sage growing in primary sfc. Rwy 03-21 sagebrush growing on west portion of rwy. Rwy 03-21 ltd by arpt opr to 8000 lbs single wheel gear. Sfc conds not rptd.
